RE: Kolomoki-Spring Creek Mitigation Area -200410120  
Mitigation Status and Credit Release Request  
Kolomoki Farm, LLC

**Kolomoki Spring Creek Mitigation Bank  
Mitigation Status and Credit Release  
June 25, 2012**

Kolomoki Mitigation Bank  
Spring Creek Construction Photos  
January 2012 through May 2012

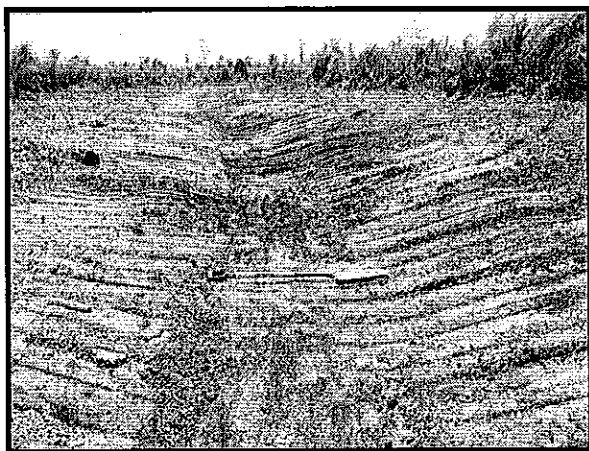
Photo 1: Standing at the northern section of T1B overlooking newly worked channel, facing downstream (early January 2012).

Supplemental stream channel work (19% of SCMA's total channel restoration linear footage) was completed in fall 2011. Approximately 2,800 linear feet of the T1-B stream was reworked. Once soil conditions permitted, the willow thicket which covered T1-B was removed and the stream channel excavated. In February 2012, additional adjustments were made to the channel based on further survey data and site assessments after bankfull events.

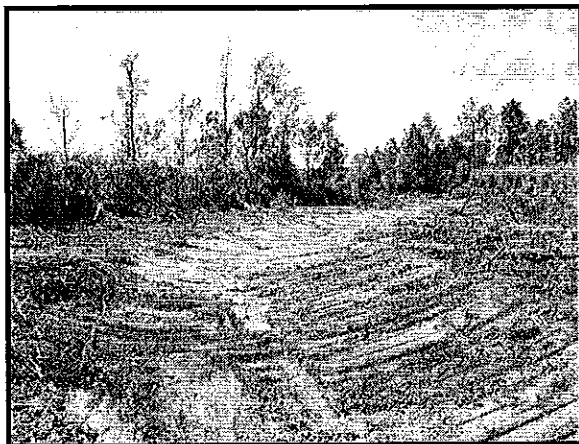
Photo 2: Standing at T1B after initial construction work along meander, facing downstream (early January 2012).

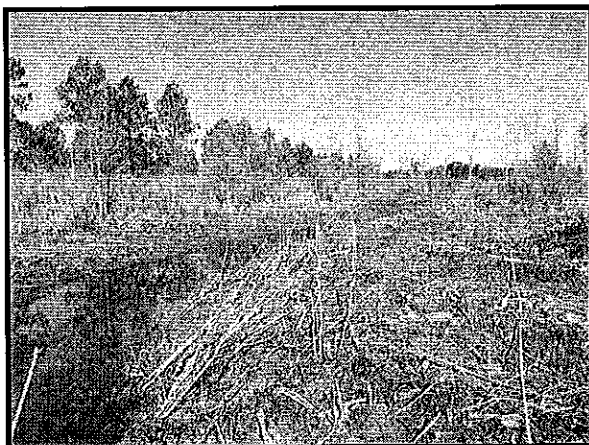
Photo 3: Standing at the right bank of T1-B overlooking the meander apex, facing upstream (January 30, 2012).

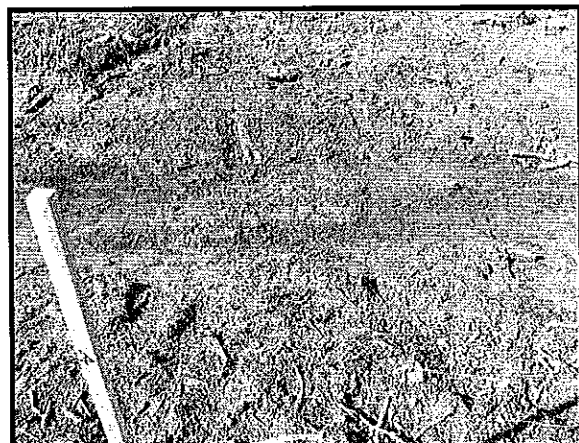
Photo 4: Survey stake placed at point of bedrock within streambed (January 30, 2012).

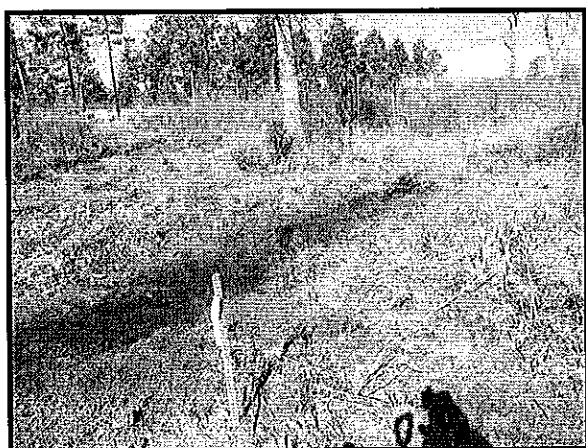
Photo 5: Survey stakes placed at head of T1B identifying point of slightly higher elevation and where additional work will be done (January 30, 2012).

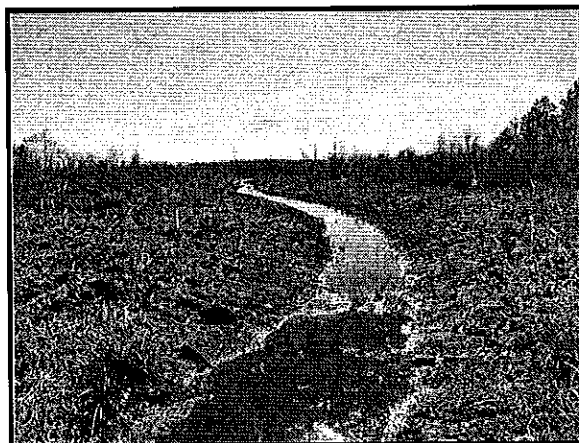
Photo 6: Small riffle located within T1-B after final construction (February 2012).

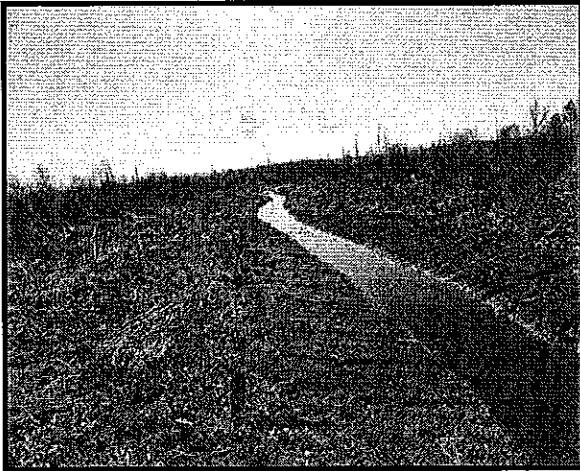
Photo 7: T1-B the day before bare-root seedlings are planted (February 2012).

In March 2012 approximately 2,500 bare root seedlings were replanted within the 50' T1-B riparian buffer restoration area (approximately 6.4 acres). These seedlings included bald cypress, green ash, swamp chestnut oak, swamp tupelo, and water hickory. No additional shrub species were planted because of the natural recruitment occurring within the old lake bed.

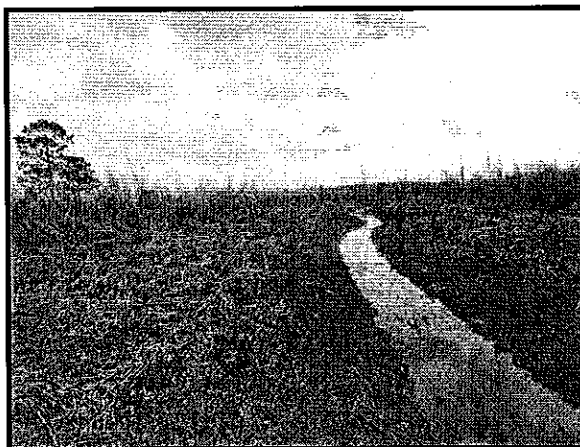
Photo 11: Bare-root seedlings being identified for baseline monitoring after planting of area (March 2012).

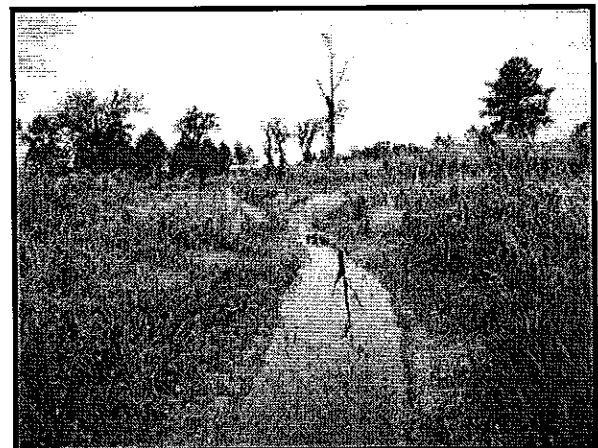
Photo 12: Upper T1-B after construction and planting with herbaceous vegetation growing within the riparian buffer (May 2012).

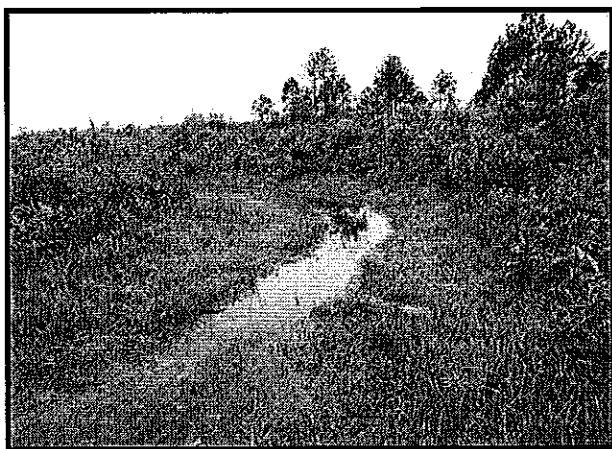
Photo 13: Lower T1-B after construction and planting with herbaceous vegetation growing within the riparian buffer (May 2012).

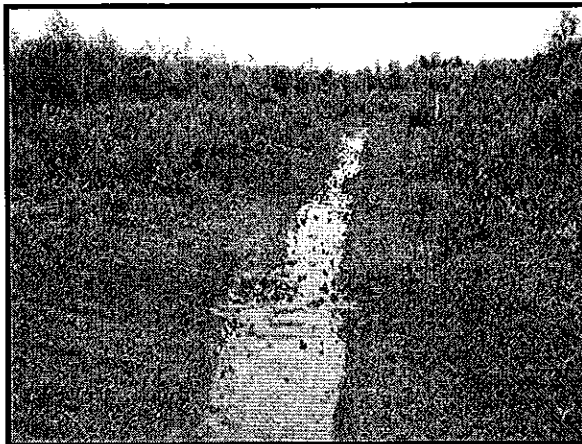
Photo 14: Stair-step riffle area within T1-B (May 2012).

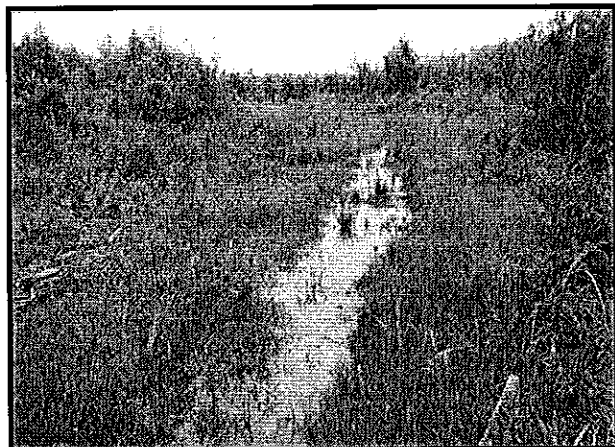
Photo 15: Lower section of T1-B with point bar and herbaceous vegetation, but with less rocky substrate (May 2012).

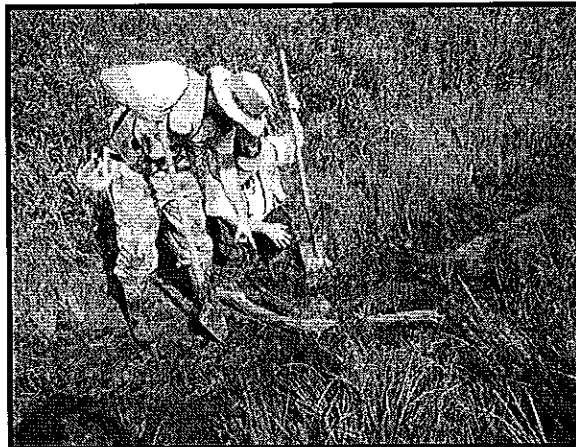
Photo 16: Installing woody debris and water rocks to create habitat diversity within channel.

In June 2012 supplemental woody debris was placed, by hand, throughout the T1B stream channel. This woody debris should provide additional habitat for macroinvertebrates and fish.

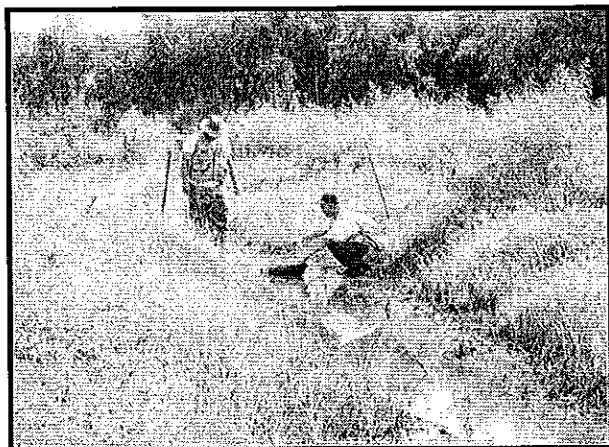
Photo 17: Installing cypress logs (woody debris) to create fish and macro invertebrate habitat.

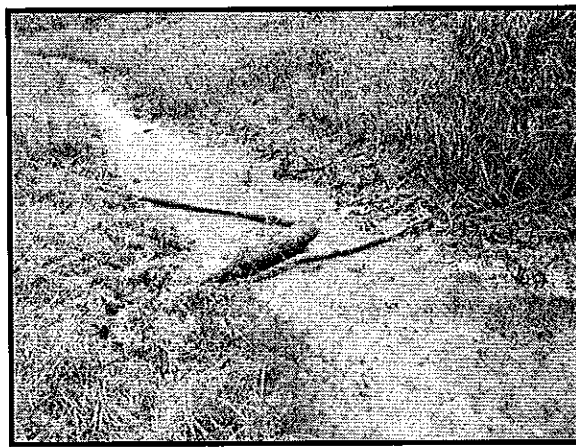
Photo 18: Small woody debris structure in lower station of T1B.
